# Gorgon Gas Development and Jansz Feed Gas Pipeline

## Five-year Environmental Performance Report 2020–2025

<b>Document ID:</b>	ABU250800077
<b>Revision ID:</b>	1.0
<b>Revision Date:</b>	5 November 2025
<b>Information Sensitivity:</b>	Public

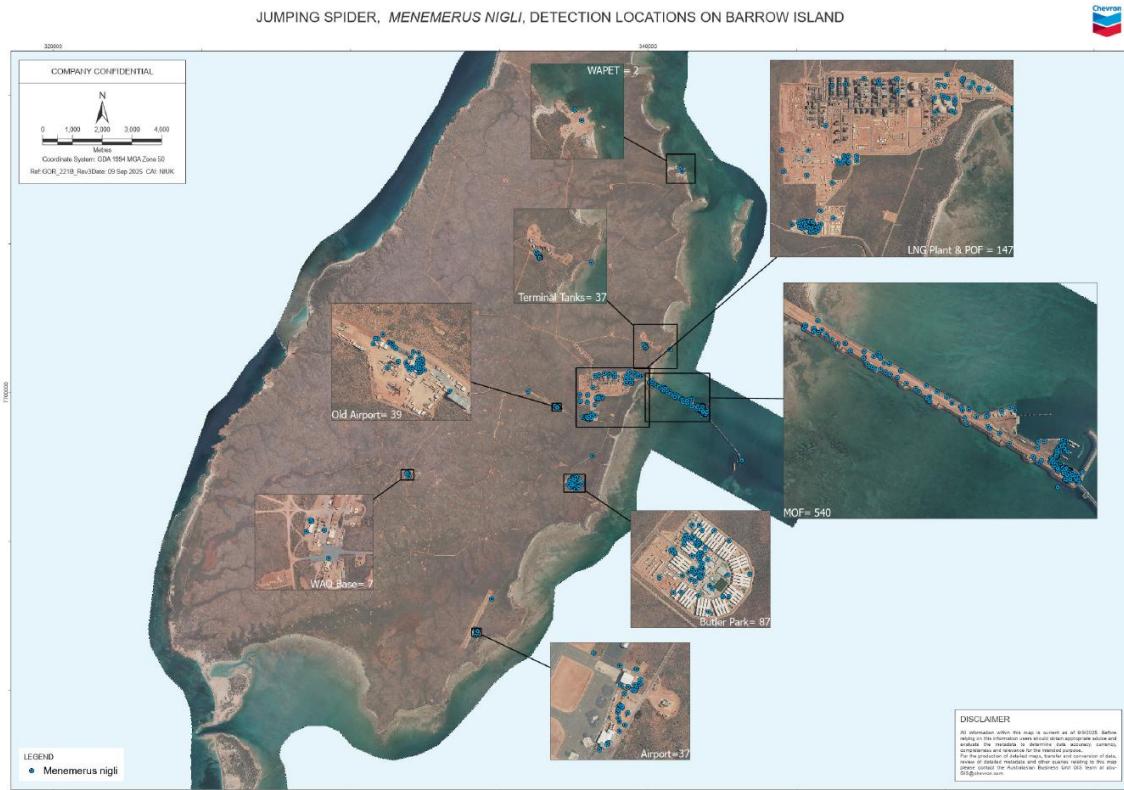
**Figure 3-1: All known detections of Jumping Spider (*Menemerus nigli*) on Barrow Island.**

<b>NIS Management Program</b>	
<i>Jumping Spider (Menemerus nigli)</i>	
<ul style="list-style-type: none"><li>October 2011 - <i>Menemerus nigli</i> (<i>M. nigli</i>) was first detected during NIS surveillance activities. Taxonomic uncertainty existed initially, with the species identified as a Barrow Island native, <i>Clynotis</i> sp. 1. Subsequent species identification changes occurred periodically until 2021, when the species identification was confirmed as <i>M. nigli</i> and non-indigenous to Barrow Island. Following identification, a First Response was initiated, which included delineation surveillance for this species.</li><li>During the Reporting Period, CAPL consulted with the QEP (2021) and relevant SMEs regarding the presence of the Jumping Spider, <i>M. nigli</i>, on Barrow Island. It was determined that <i>M. nigli</i> is a NIS that has been introduced to Barrow Island as a result of and after the Gorgon Gas Development commenced. In accordance with MS 800 Conditions 9.2 and 10.3, the QEP wrote to the Minister for the Environment on 16 September 2021 to notify them of this establishment and received a response 8 November 2021. Given the uncertain effects of <i>M. nigli</i> on Barrow Island native species and ecosystems and the potential for adverse impacts from chemical eradication options, the QEP recommended that eradication and control was not possible for <i>M. nigli</i>.</li><li>CAPL developed an NIS Management Procedure (GOR-COP-03307), as required under the QMS. The objective of this procedure is to prevent the proliferation of <i>M. nigli</i> into new areas associated with CAPL activities and to mitigate management actions against non-target species. The procedure outlines surveillance targets for both tenure and natural areas, and chemical treatments of selected infrastructure to prevent proliferation. These targets include annual reporting requirements and surveillance of known and potential habitats. During the Reporting Period, <i>M. nigli</i> were detected on infrastructure at the Materials Offloading Facility (MOF), Butler Park, the Barrow Island Airport, the Old Airport, Terminal Tanks, POF, WAPET Landing, WAO Base and the GTP (Figure 3-1).</li><li>Structured day surveillance was conducted on tenure and in undisturbed areas away from infrastructure. <i>M. nigli</i> has been detected associated with buildings, concrete foundations and concrete blocks, and within monitoring stations around CAPL infrastructure. No detections have been made in any undisturbed/natural areas.</li><li>Within the last 12 months, there were 9 detections of <i>M. nigli</i> identified at a new location - WA Oil Base. Following the initial detection in September 2024 at WAO Base, an increased insecticide treatment</li></ul>

program was implemented, and additional surveillance was undertaken to determine the effectiveness of these treatments. There have been no detections at this location since February 2025. The NIS Management Procedure remains active.

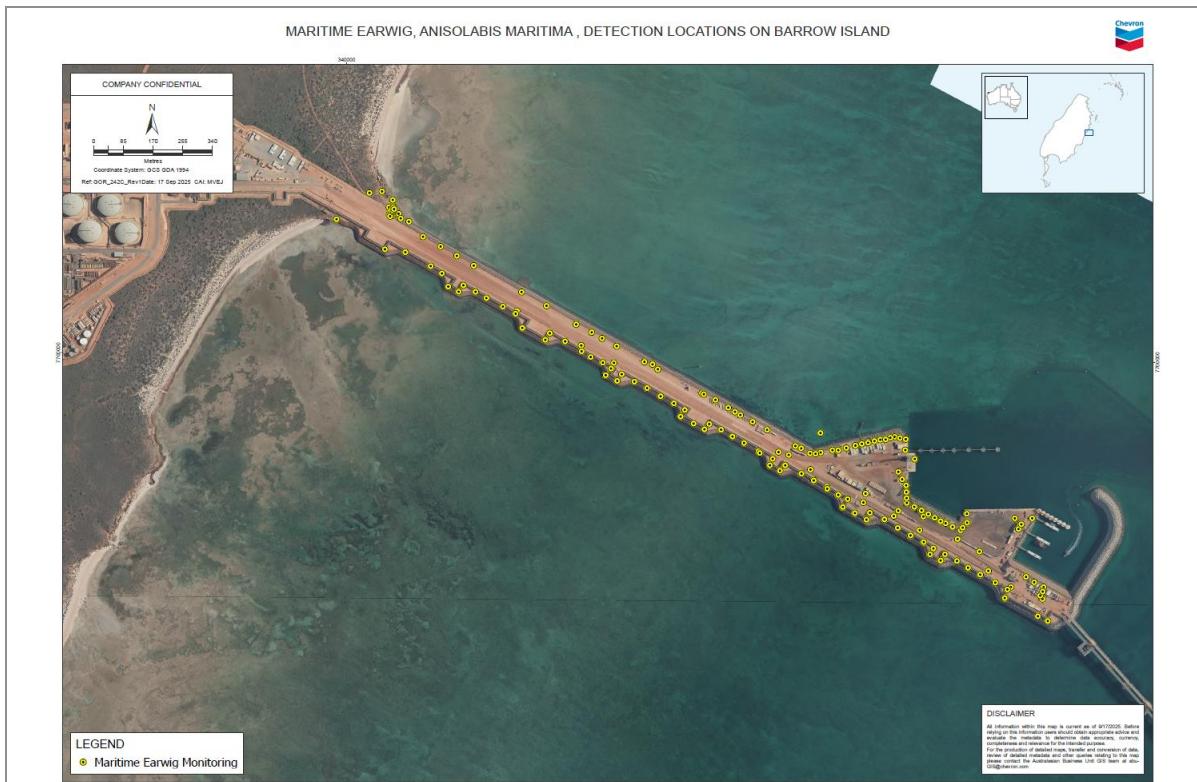
**Figure 3-2: All known detections of Maritime Earwig (*Anisolabis maritima*) along Causeway, Barrow Island. (Date: 16 September 2025).**

- September 2024 - *A. maritima* was detected at the base of the Causeway X-blocks at the junction of Terminal Beach for the first time. *A. maritima* continues to be detected in this location. Given this change, in consultation with the QEP, the decision was made to move the response from First to Inclusion Response. To support the response, CAPL engaged the QEP members and independent SMEs to attend a workshop focusing on identifying knowledge gaps, understanding *A. maritima* ecology and potential ecological impacts; as well as identifying strategies for control, containment and eradication. Subsequent activities and studies have commenced to address the above focus areas.
- August 2025 - *A. maritima* was detected at the base of the Causeway X-blocks at the junction of Bivalve Beach for the first time.

Delineation surveillance activities have been conducted across multiple beach locations on Barrow Island, and to date, *A. maritima* has not been detected outside of the aforementioned known locations. The response remains open and will be reported on in the next EPR.

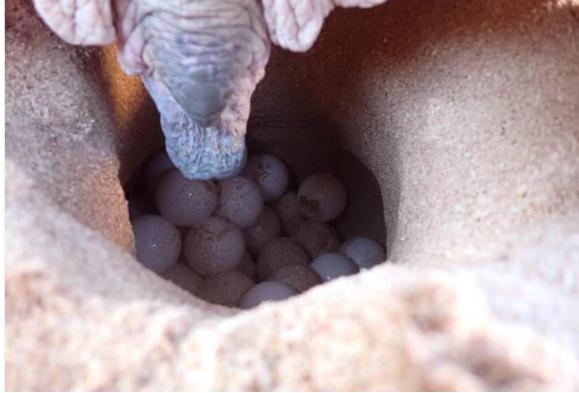
<b>Results</b>	<p>The results of Flatback turtle incubation success monitoring during the Reporting Period are presented in Table 4-3, Figure 4-6 and Figure 4-7 (Ref. 45).</p>
<b>Discussion</b>	<p>Incubation success monitoring results have largely remained within control limits during the Reporting Period. During the 2024/25 season storm surge flooding from Tropical Cyclone Sean resulted in the inundation of the majority (62%) of marked clutches, which significantly reduced volume of complete nests available for assessment, and likely biased incubation success parameters due to low sample sizes. (Ref. 45).</p> <p>Additionally, incubation temperatures reached record highs at Barrow Island during 2024/25 season which subsequently resulted in a short incubation period of less than 46 days. Given this incubation duration, clutches laid before approximately 4 December 2024 may have hatched successfully before the cyclone's impact. Thus, the initiation of nest marking on 6 December 2024 likely resulted in a negative bias for observed incubation success parameters and the reduction in hatching probability caused by the TC Sean is not likely to have been consistent throughout the summer. Therefore, actual incubation success and hatchling production may have been significantly higher than indicated by observation during the monitoring period. Other sea turtle species have demonstrated shifts in phenology which have mitigated adverse impacts of climate change on reproductive output, and the evidence of an earlier nesting season at BWI during 2024/25 season may have reduced the impact of TC Sean (Ref. 45).</p>

**Figure 4-6: Control Chart for Mean Egg Hatching Probability for Complete Clutches at Barrow Island. All Routine Monitored Beaches (Mushroom, Terminal, Bivalve, and Inga are combined)**

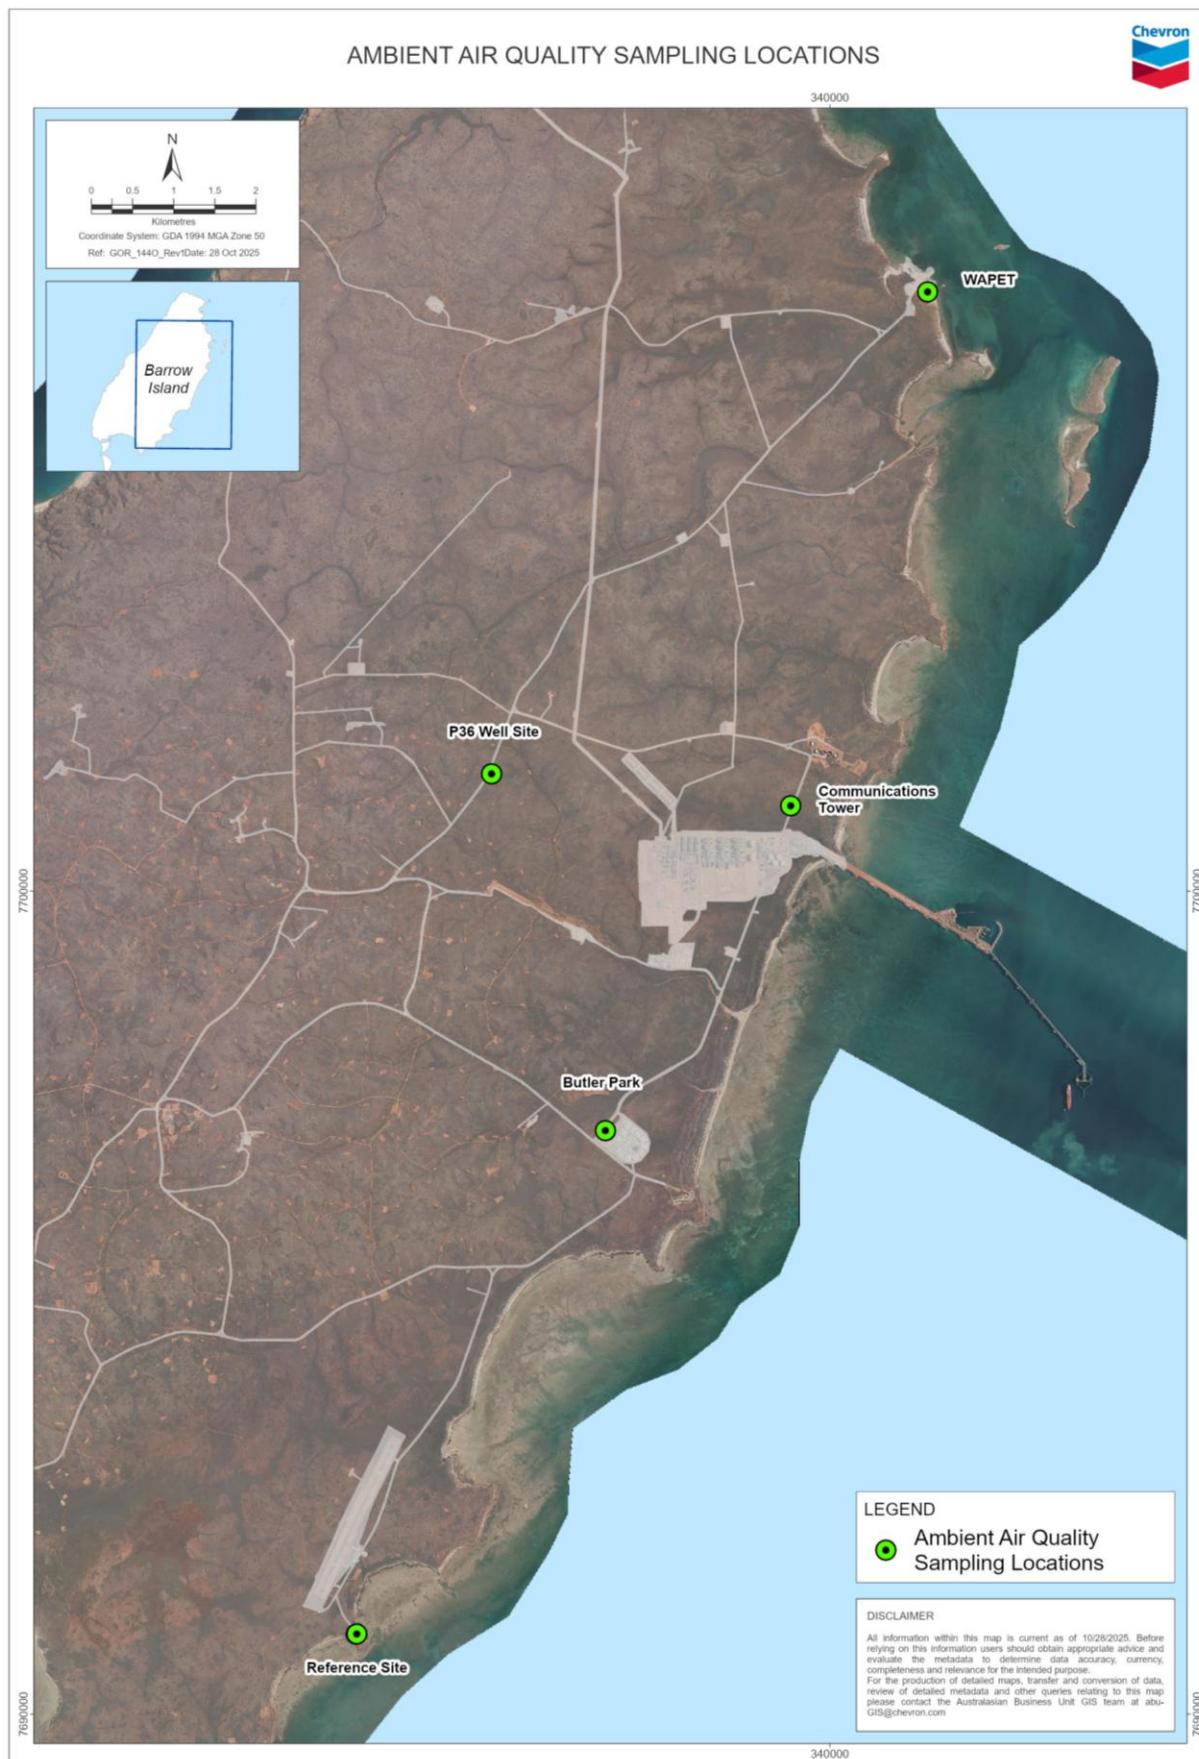
Figure 8-1: Ambient Air Quality Monitoring Locations August 2020 to August 2025

Ambient Air Quality	Stack Air Quality (Major Emission Sources)
<b>Locations:</b>	Butler Park (workforce accommodation) Air Quality Monitoring Station (AQMS) Communications Tower (CT) AQMS (close to the GTP) Other locations beyond the GTP	5 x GTGs 6 x LCGT
<b>Frequency:</b>	Continuous	Quarterly
<b>Parameters</b>	Varied per location, but includes: NO, NO <sub>x</sub> , NO <sub>2</sub> PM <sub>10</sub> , H <sub>2</sub> S, SO <sub>2</sub> NMVOC (non-methane volatile organic compounds) CO, O <sub>3</sub> , weather	NO <sub>x</sub> CO NMVOC

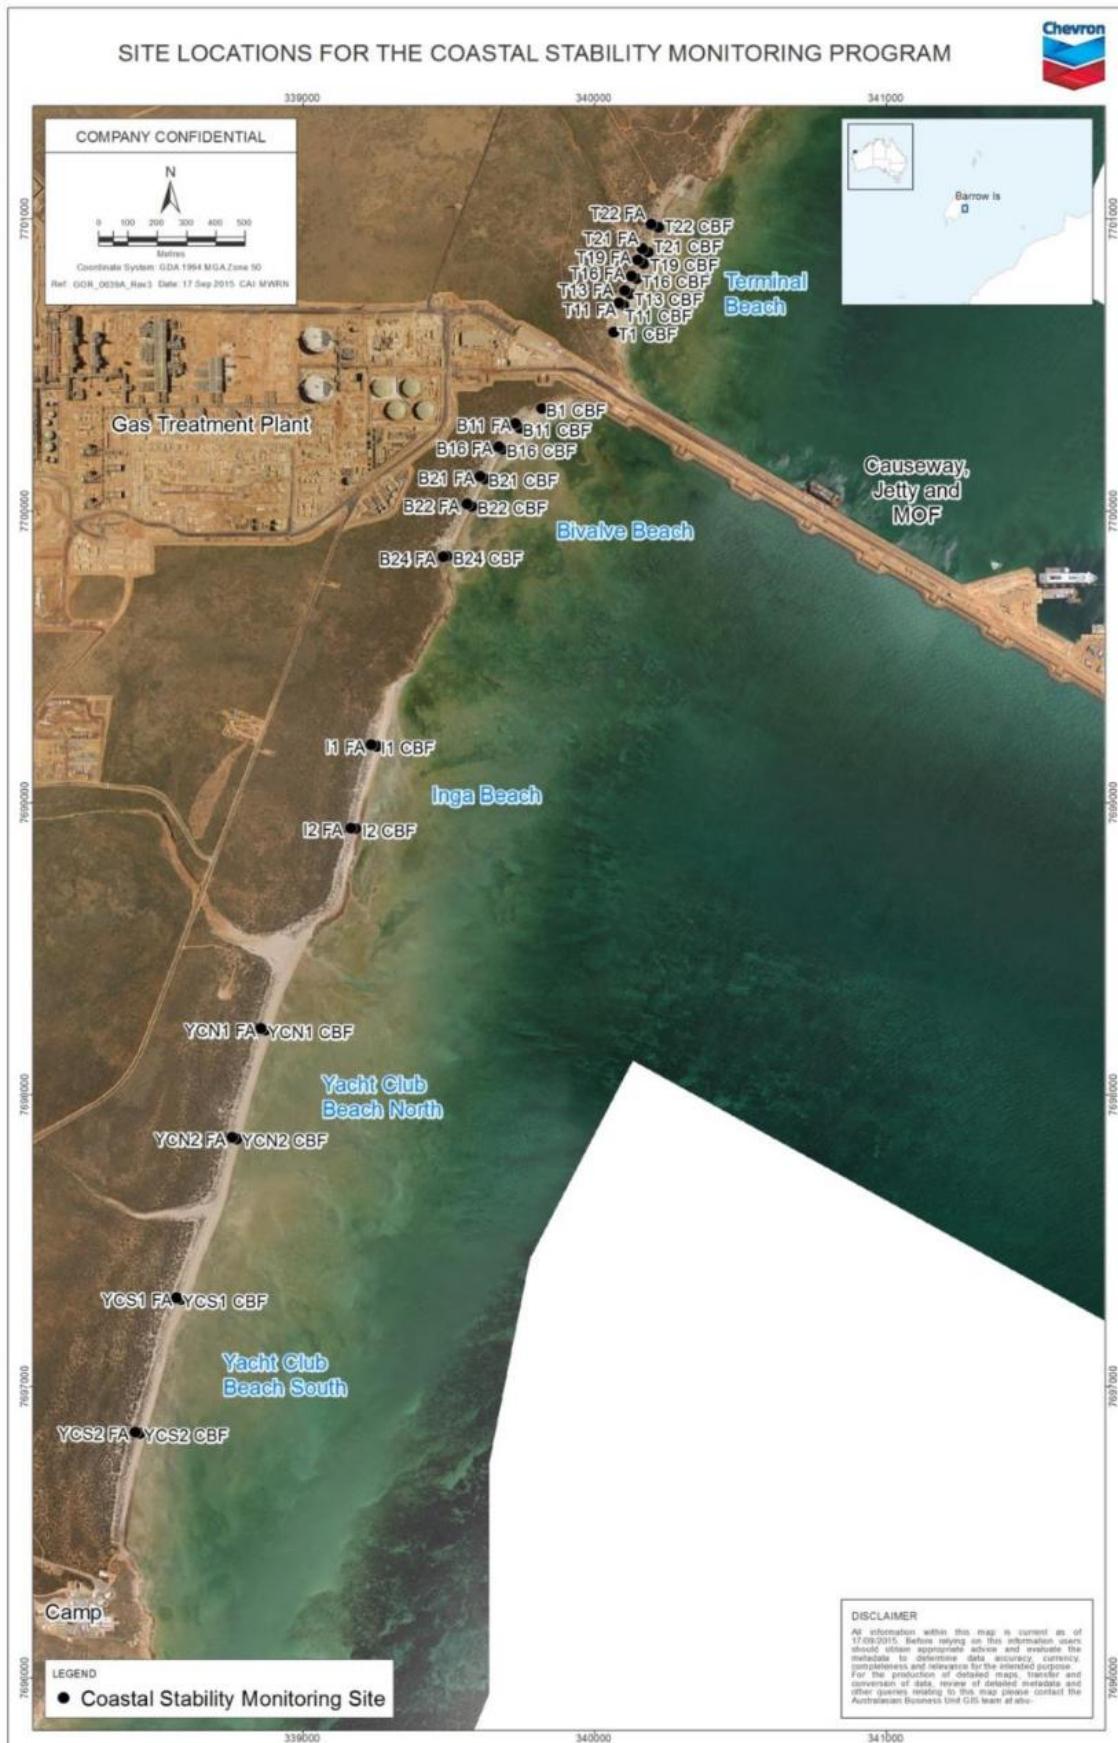
**Figure 9-1 Site Locations for the Coastal Stability Monitoring Program**

During the Reporting Period, management trigger exceedances were recorded for both volume and slope at monitored transects on Bivalve Beach (B11 and B22; Figure 9-1); however, the number of exceedances recorded varied between surveys (Table 9-6, Table 9-7).

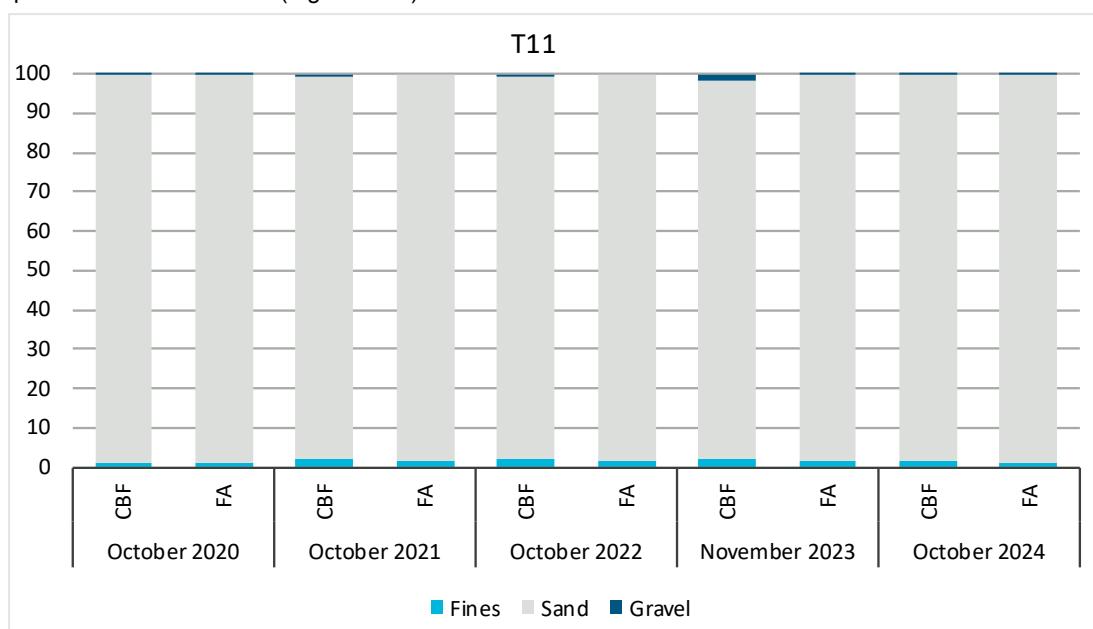
**Figure 9-10: PSD of Sediment Samples at T11 (southern end of Terminal Beach) for Routine Biannual Surveys, October 2020–October 2024**

PSDs of surface samples (0.0 m) are displayed in Figure 9-10 or monitoring transects at Terminal Beach (T11, T22) and Bivalve Beach (B11, B22) to demonstrate sediment composition changes occurring at the southern and northern sections of each beach over the Reporting Period (Figure 9-10–Figure 9-13). Summaries of sediment composition changes at Inga, YCN, and YCS beaches are also provided, and additional graphs are displayed in Figure 9-14–Figure 9-19.

Over the Reporting Period, minor variations in PSD have been observed at T11 CBF (southern end of Terminal Beach), with fines and gravel portions contributing <5% to the distribution for each survey in the Reporting Period (Figure 9-10–Figure 9-10). Sediment coverage at the northern end of Terminal Beach has decreased and bedrock has become exposed at the most northern CBF sites, including T22, which has had no sediment coverage since May 2018 (Figure 9-10, (Ref. 8)).

At the southern end of Terminal Beach (T11), no notable changes in PSD have occurred in FA samples (Figure 9-10). At the northern end (T22), there has been minor variability in the amount of gravel in FA samples since October 2020 (Figure 9-11).

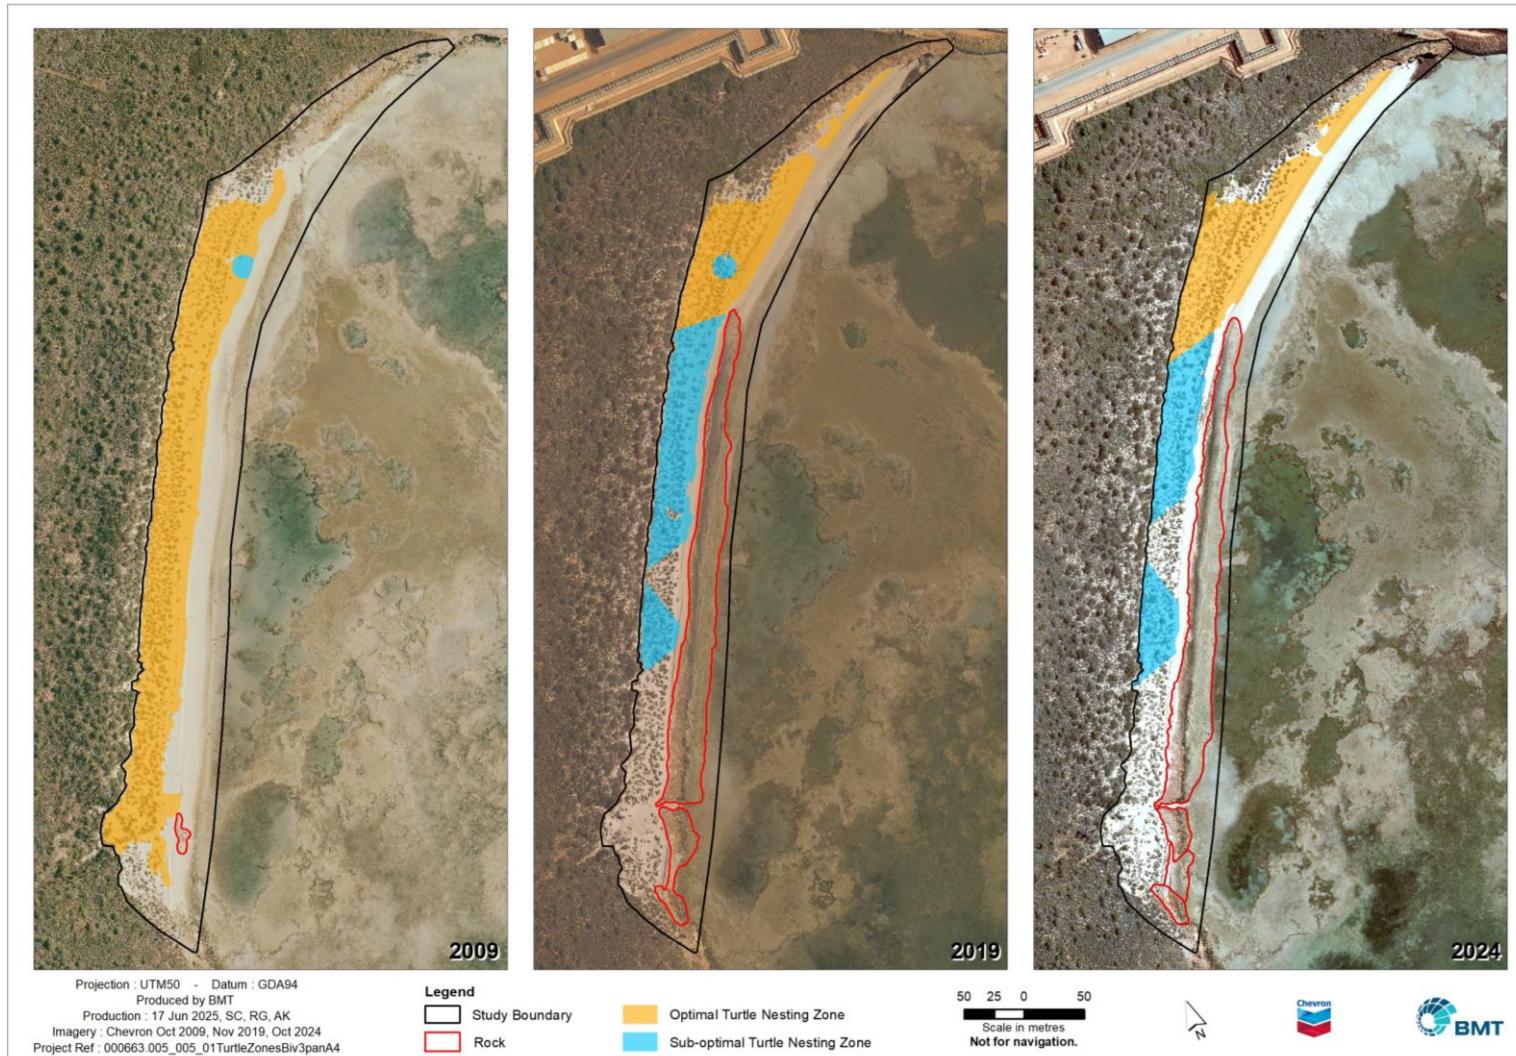
**Figure 9-22: Marine Turtle Nesting Habitat Zones for Bivalve Beach**

Since November 2019, fluctuations in rock exposure in the middle third of Terminal Beach has caused variability in the sub-optimal nesting area (ranging between 0.03 ha in 2021 and 0.77 ha in 2023) but optimal nesting habitat was relatively stable (ranging between 0.81 ha in 2024 and 0.92 ha in 2023). Typically, the northern third of Terminal Beach is classified as unsuitable nesting habitat, the middle third as sub-optimal nesting habitat, and the southern third as optimal nesting habitat.	
<i>Bivalve Beach</i>	
The area of mapped optimal nesting habitat at Bivalve Beach progressively reduced between 2009 and 2015, from 2.1 ha in October 2009 to 0.78 ha in October 2015. Since 2015, optimal nesting habitat has stabilised and averaged 0.80 ha (0.89 ha in October 2024). Optimal nesting habitat has been reclassified to sub-optimal or unsuitable along the southern two-thirds of the beach where intertidal rock has been exposed. In the northern third of the beach, optimal habitat has been created further north of the baseline nesting area on the accreted section of beach (Figure 9-22).
